RAILROAD ACCIDENT REPORT

**COLLISION OF
PORT AUTHORITY OF ALLEGHENY COUNTY
TROLLEY CAR NO. 1790 AND BUS NO. 2413
PITTSBURGH, PENNSYLVANIA
FEBRUARY 10, 1978**

REPORT NUMBER: NTSB-RAR-78-5

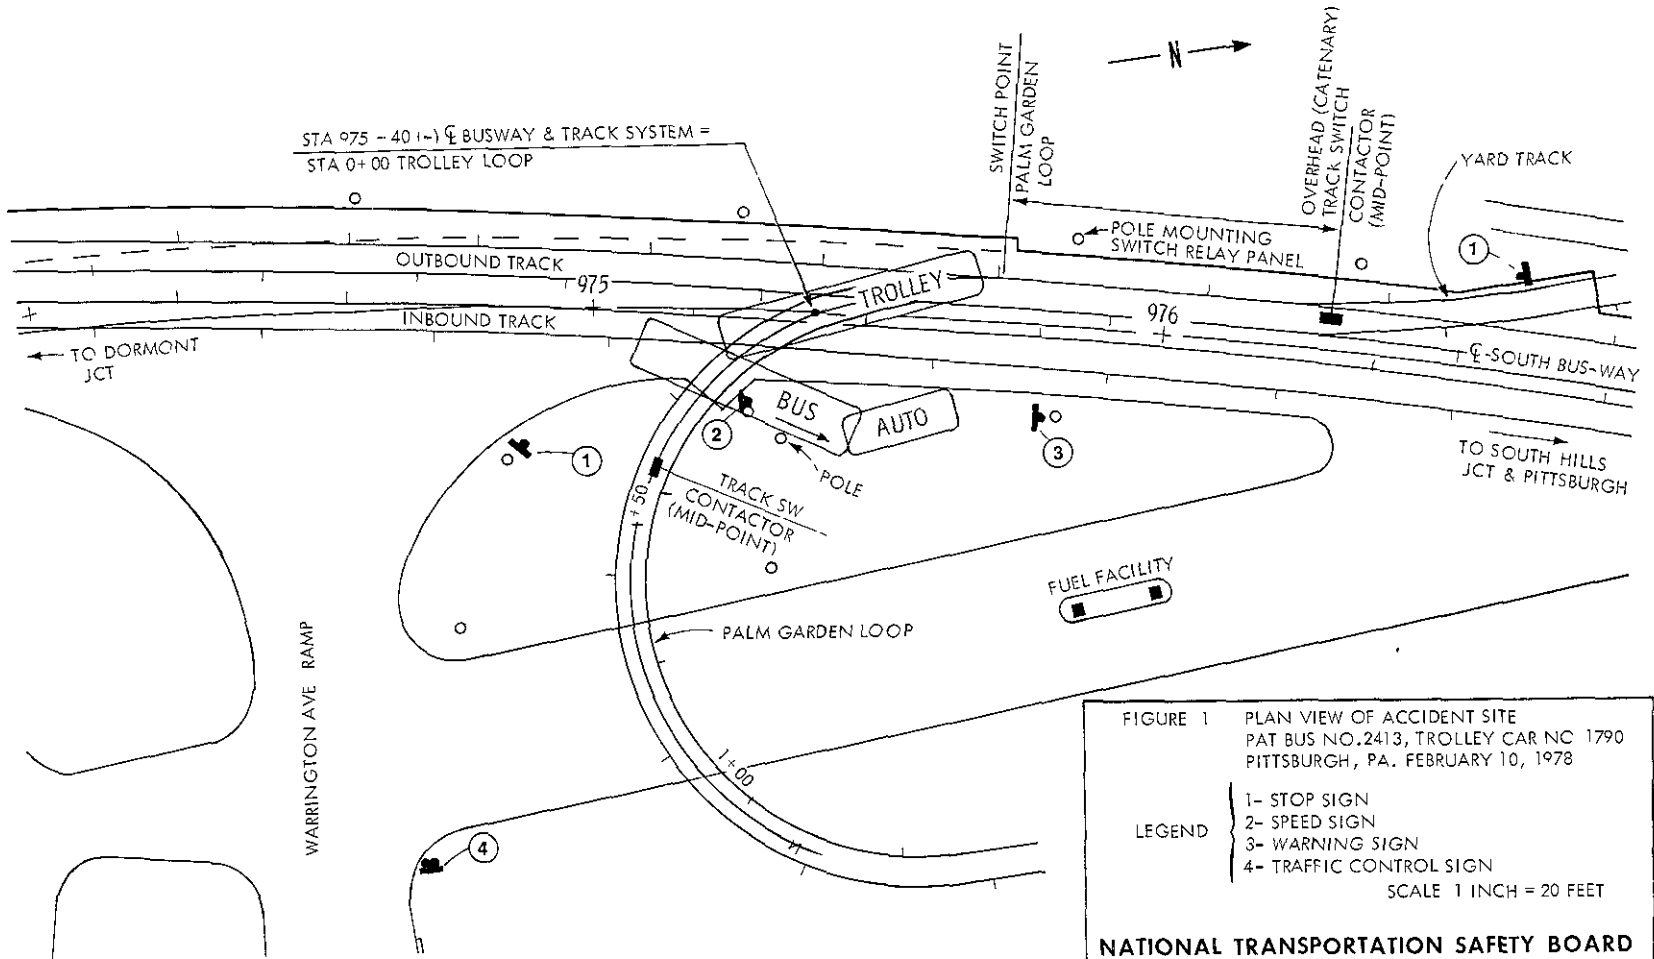
FIGURE 1 PLAN VIEW OF ACCIDENT SITE
PAT BUS NO. 2413, TROLLEY CAR NC 1790
PITTSBURGH, PA. FEBRUARY 10, 1978

There are two main tracks which run north and south through the accident area. The west track is the "outbound" track and the east track is the "inbound" track. The two tracks are embedded in concrete, thus permitting the surface to be used as a roadway. The roadway is on a 3-percent descending grade outbound. The roadway curvature varies to a maximum of 5° to the left outbound through the Palm Garden Loop switch area. There are no pertinent sight impediments near the switch. (See figure 1.)

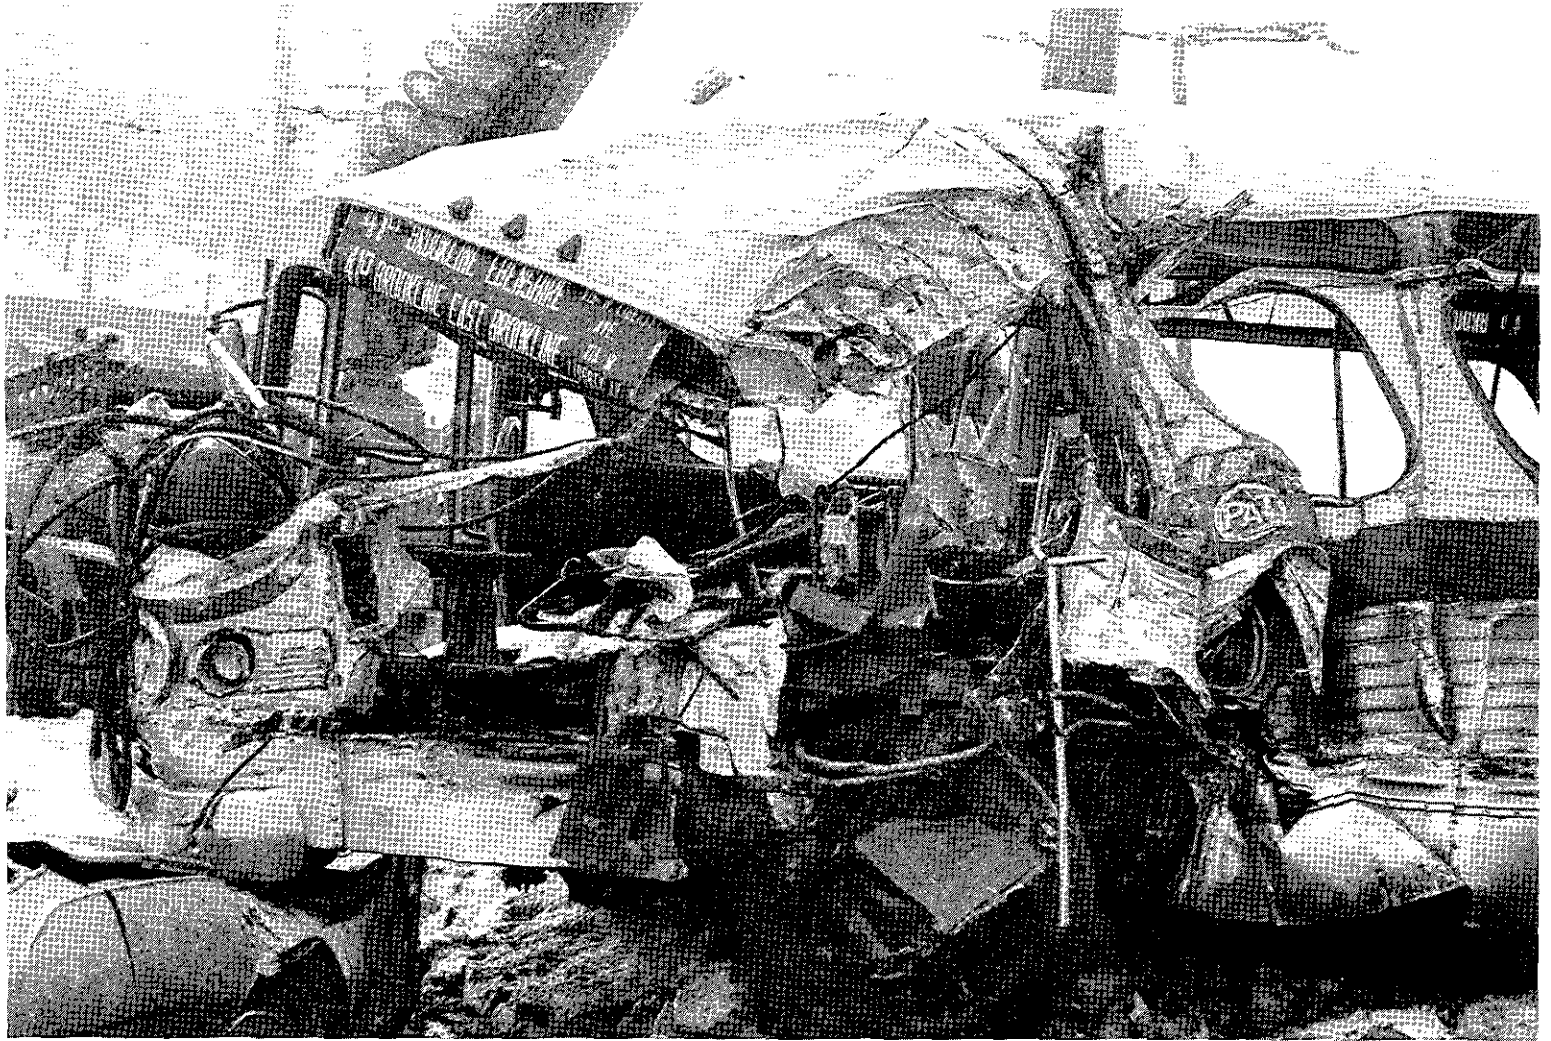
Figure 2. PAT bus No. 2413.

The trolley car struck the bus on the left front corner. The upper section of the bus was displaced rearward approximately 5 feet and downward 3 feet. The roof structure above the windshield frame was displaced to the left 2 feet, and the windshield was missing. The trolley car penetrated into the bus about 3 feet at the deepest point. Major deformation was evident along the left side for almost 15 feet. (See figure 2.)

An 11-inch-wide indentation on the rim of the left front wheel contained deposits of red paint where the trolley car's anticlimber hit the wheel. The bus came to rest against a catenary pole, which contacted the bus on the right front side causing the two front side windows to jam.

The bus instrument panel was damaged extensively. The steering wheel drive mechanism was inoperable. Seats and stanchions on the left side from the front of the bus through seats L-8-9 were detached and bent to varying degrees. The backs of several seats behind L-8-9 were bent forward. There was minimal damage to the interior on the right side of the bus. Some damage was caused by rescue personnel during their efforts to evacuate the injured.

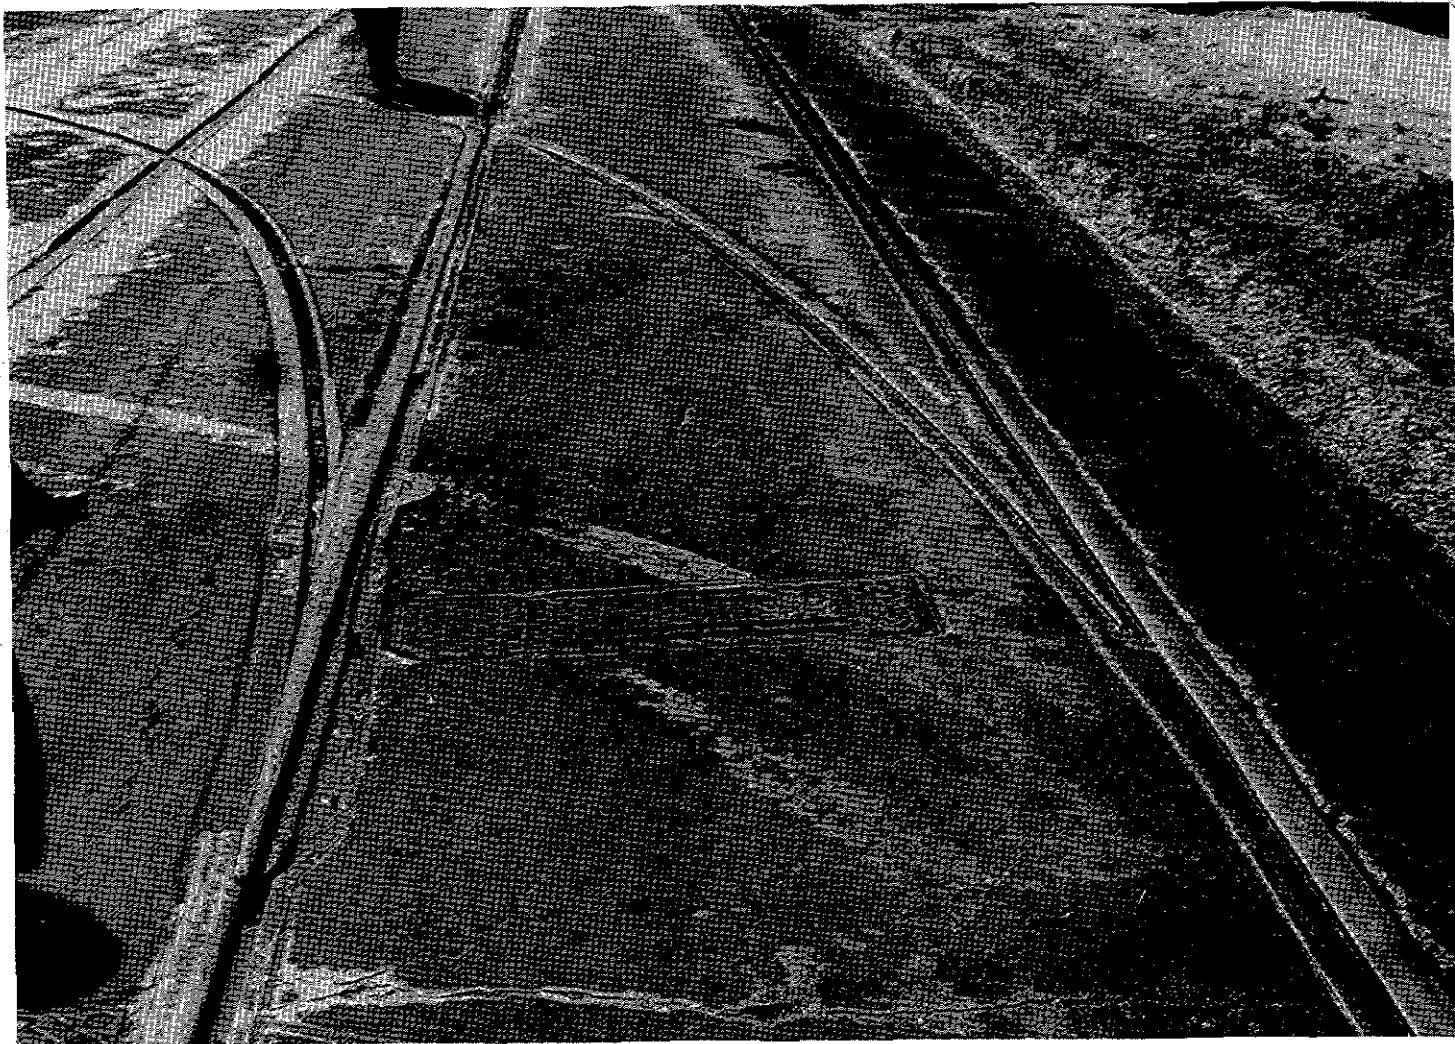
Figures 3. Track switch.

The switch has one movable point which is operated by the electromagnetic switch machine. (See figure 3.) The switch machine consists of two coils which, when separately energized, lines the route for either a straight movement or for the curve. There is no positive locking device, and the switch is held in either position by spring pressure. Power to energize and operate the switch machine and the relay panel is obtained from the 600-volt d.c. catenary.

The left front wheel contour and flange were found to be in good condition with no marks to indicate that the wheel "picked" 3/ the switch. The switch point had no marks to indicate it had been picked. The switch point fitted the stock rail, and it did not roll or raise when a car moved over it.

On February 14, 1978, the track switch for the Palm Garden Loop was made to operate semi-automatically. An operator entering the Palm Garden Loop now has to stop his car and position the switch for the curve manually. It will then restore for a straight move automatically after a trolley car passes a closure contactor in the loop catenary. Specific instructions are given for operating a trolley car over an electric switch. (See appendix B.)

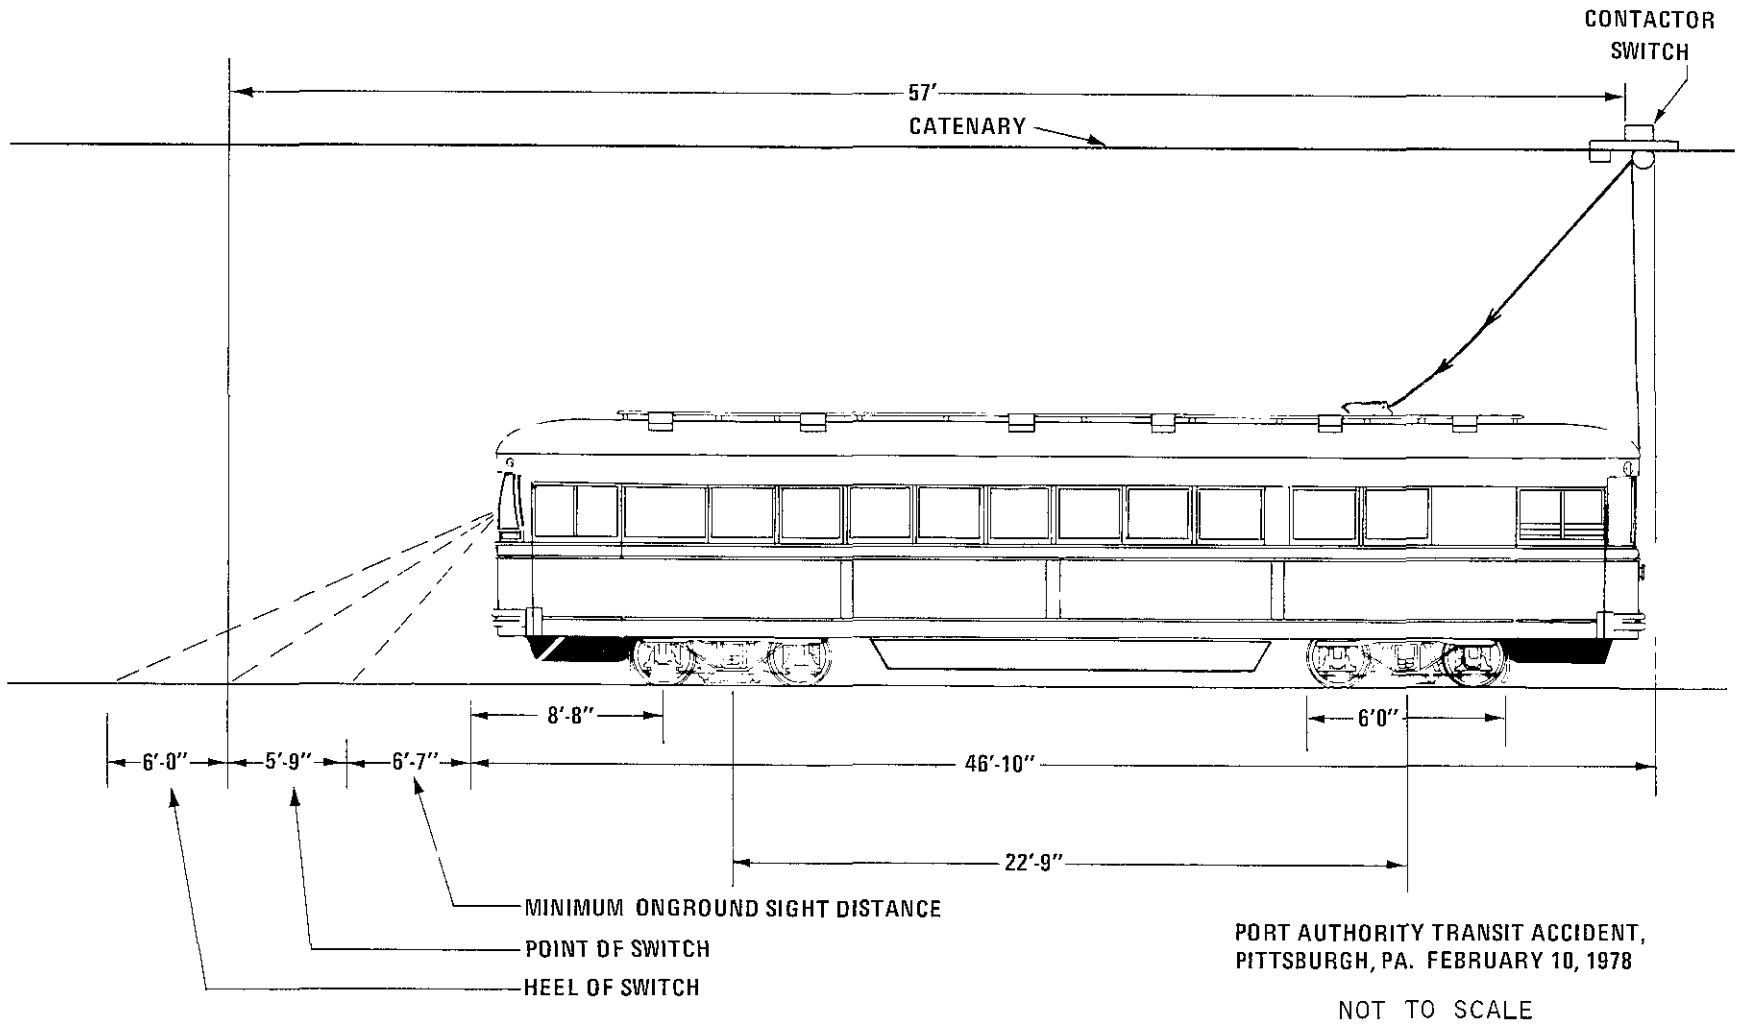
Figure 4. Trolley car dimensions and some average sight distances for a typical operator.

The contactor is located 57 feet from the switch point so that an operator will have time to stop his car if the switch does not respond properly. The closest the operator can see the ground ahead is 6 to 8 feet because of the car overhang. When the trolley pole is just engaging the contactor, the point of the switch is 12 feet from the front of the car, which gives the operator about 4 to 6 feet ground view of the switch point. After the trolley pole clears the contactor, the operator's ground view of the switch point would still be 2 to 4 feet. The front of the car would be about 10 feet from the switch point, and this distance, if extended to the heel of the switch, would be about 16 feet. (See figure 4.) Movement of the switch point can be observed throughout its 6-foot length.

Trolley operators do not have positive identifying markings to let them know when the trolley pole is on the contactor. Through experience, they listen for a "thump" that is transmitted through the car as the pole leaves the contactor. This is their only indication of the trolley pole's location relative to the contactor, other than using an estimated distance from the front of the car to the switch point.

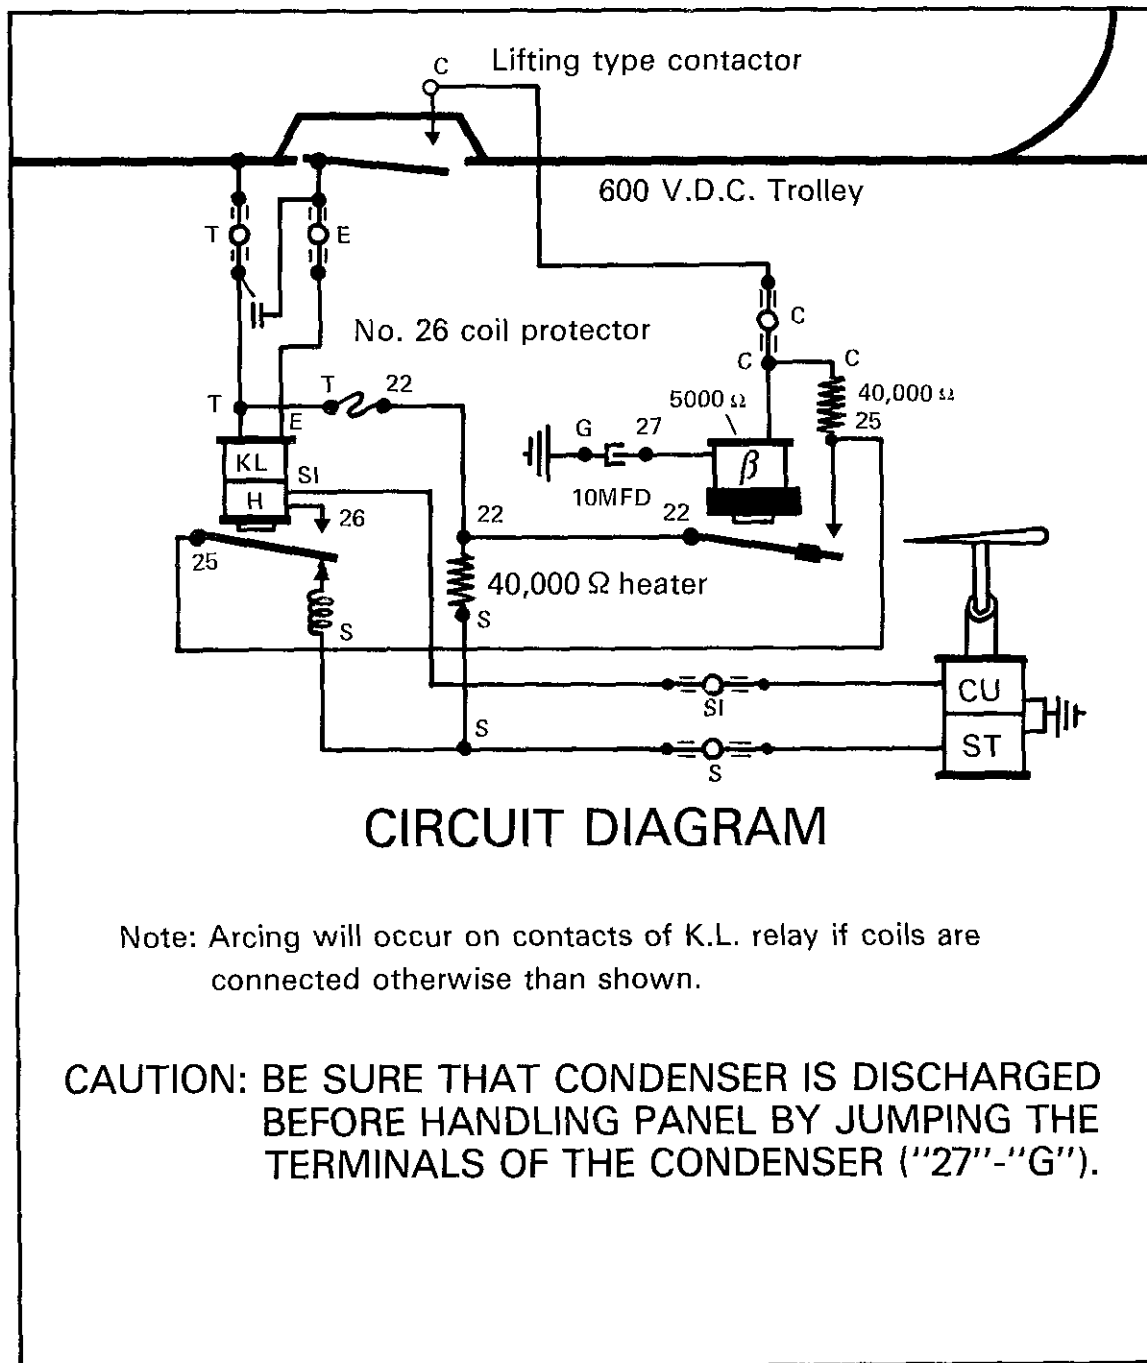
SWITCH RELAY CIRCUIT

The relay panel consists of two relays, identified as "KL" and "B," and miscellaneous components. The position of relay "KL" determines whether the switch point will be positioned for the curve or straight track. The "KL" relay operates on 60 amperes d.c. current or more. The "B" relay has to operate for the switch to assume either position. (See appendix A.)

The relay panel is the "heart" of the switch operation. The reported switch failures occurred with two different relay panels in service. Both failures reportedly occurred after the car's trolley pole had passed clear of the contactor. All operations of the switch were proper when the control relays were operated manually. Tests were made with several different cars, including car No. 1790, in an attempt to produce an undesirable response and none occurred. In summary, no failure of the switch was observed during tests, the switch operated properly from February 10 to February 14 without a failure, and the performance history of this switch circuit lends credence to its reliability.
