Ashbridges Bay Maintenance & Storage Facility for New Streetcars

Update to Portlands Action Committee

March 24, 2011

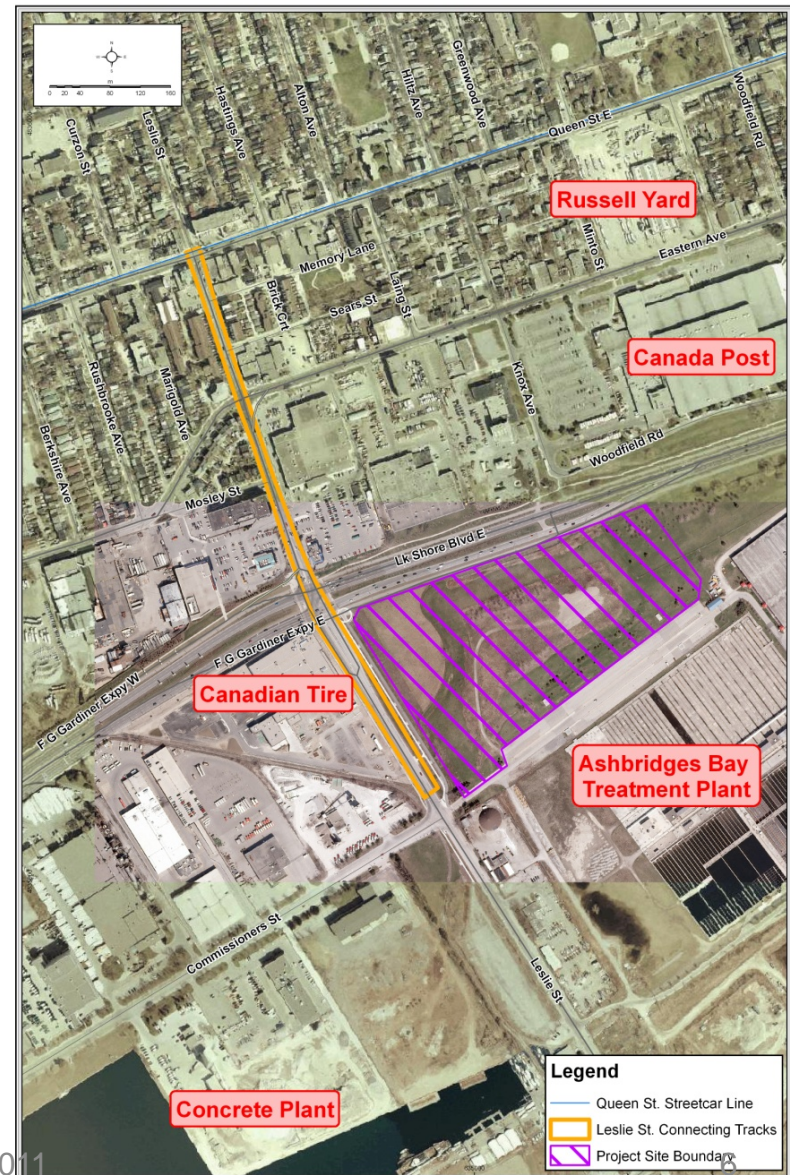
Site Layout

Layout Features:

- Store up to 100 LRVs.
- Includes a main building with a green roof designed in accordance with Toronto Green Standards, and an electrical substation.
- On-site stormwater management pond.
- Approximately 470 employees to work at the facility.
- The facility will include the following activities: daily servicing and cleaning, preventative and corrective maintenance.
- The majority of the LRVs will leave and return to the site outside of rush hour periods.

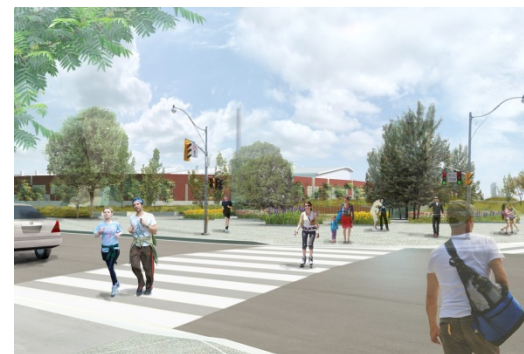
- Over 400 new trees within the site
- Majority of new plantings will be native species
- Landscape design competition will produce an inviting area for cyclists, pedestrians and other trail users
- Design will integrate with the existing Martin Goodman Trail
- Brown and Storey Architects working on detailed design

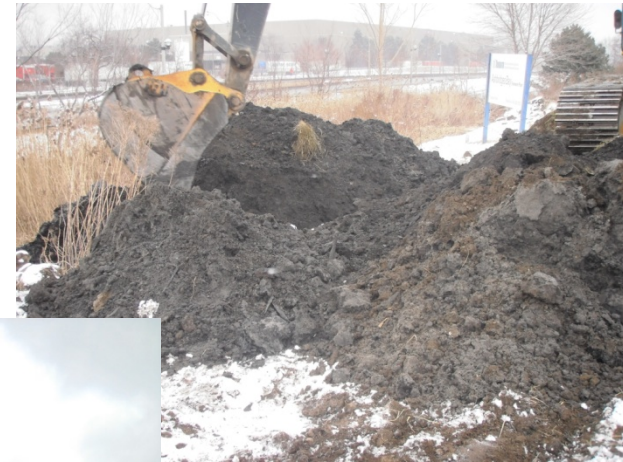
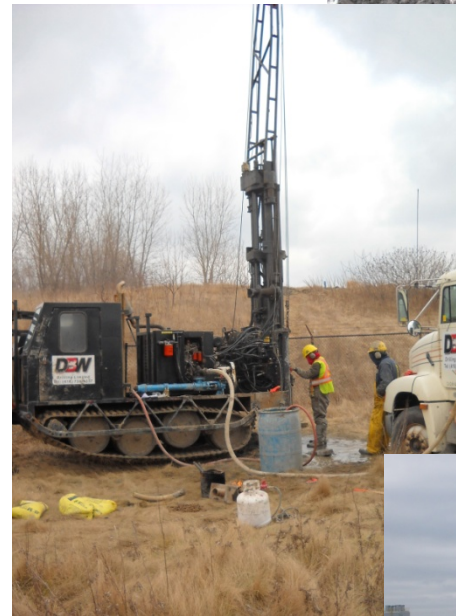
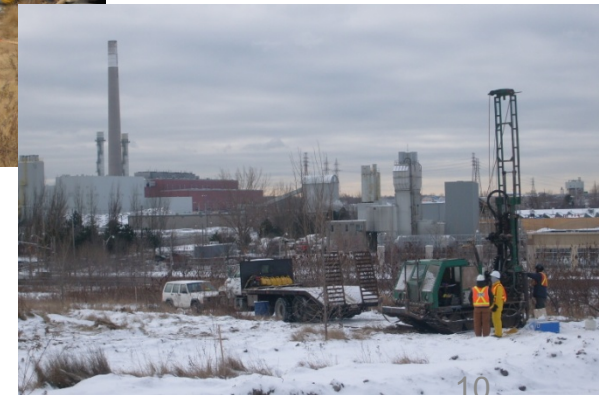
- Extensive sampling and testing in 2009-2010 by AMEC Earth & Environmental
 - 33 boreholes
 - 21 test pits
 - Monitoring Wells
 - Soil Vapour Probes
- Specific Studies / Programs
 - Waste Content
 - Phase I & II Environmental Site Assessment
 - Dust Control and Air Monitoring

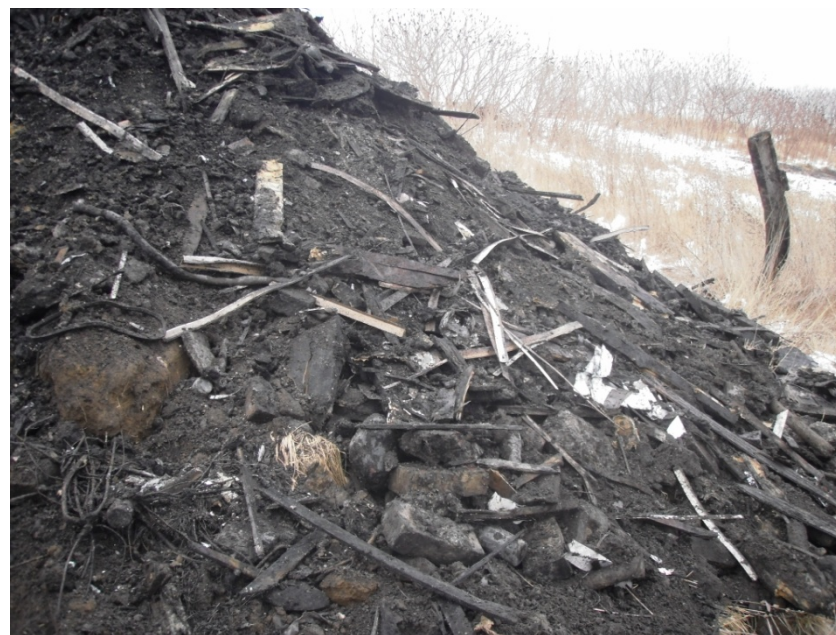
Wood and concrete debris mixed with soil and cinders.

- Metals (mainly Lead, Zinc, Arsenic, Cadmium and others)
- Polycyclic Aromatic Hydrocarbons (PAHs) - such as cinders, ashes
- Petroleum Hydrocarbons (PHCs) - such as oil, gasoline/diesel
- PCBs (trace amounts, <10 ppb)
- Volatile Organic Compounds (VOCs) – trace amount of solvents (xylenes, ethylbenzene, etc.)
- Construction Debris – concrete, metal, plastic, wood from project in the area

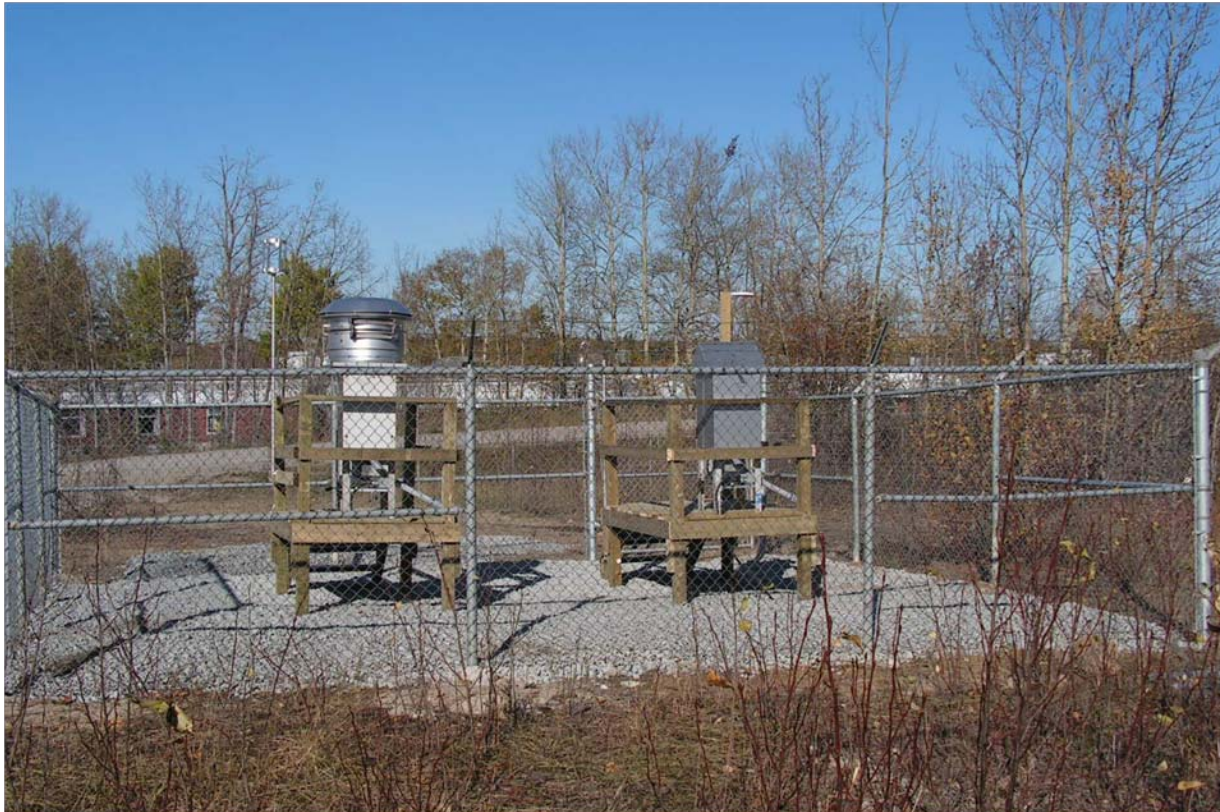
Air and Dust Monitoring Units

- Eight monitoring stations around the perimeter of the site
- Regular reporting of total suspended particulates and interpretive analysis.
- Dust sampling 24 hrs/day 7 days a week
- Wireless, audible alarms notify site security should dust levels approach thresholds

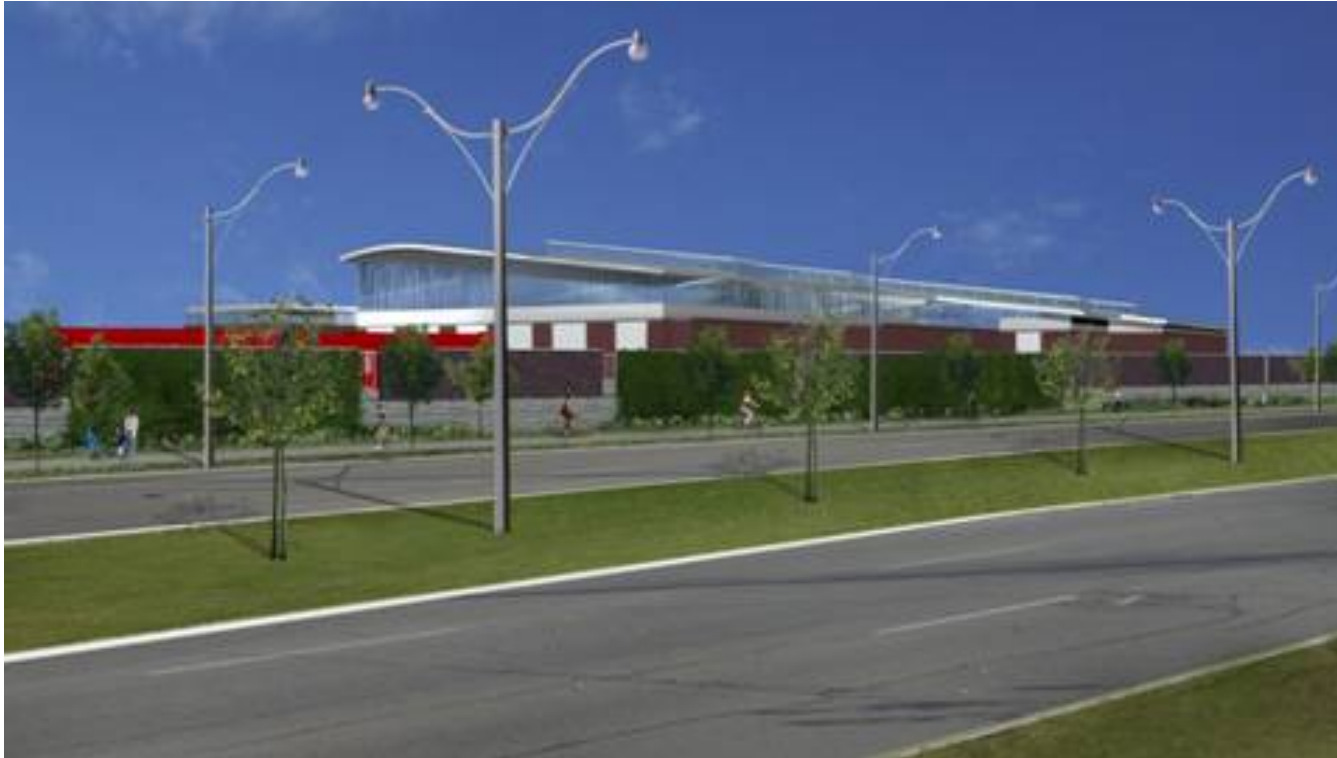
EXTERIOR PERSPECTIVE FROM LAKE SHORE BOULEVARD LOOKING SOUTH-WEST
(concept subject to change)
